The runaway defibrillator...A case of an implantable cardioverter-defibrillator that failed communication and deactivation with a magnet

Mahmoud Assaad, MD, George Degheim, MD, Christian Machado, MD, FHRS

From the Providence Heart Institute, Southfield, Michigan.

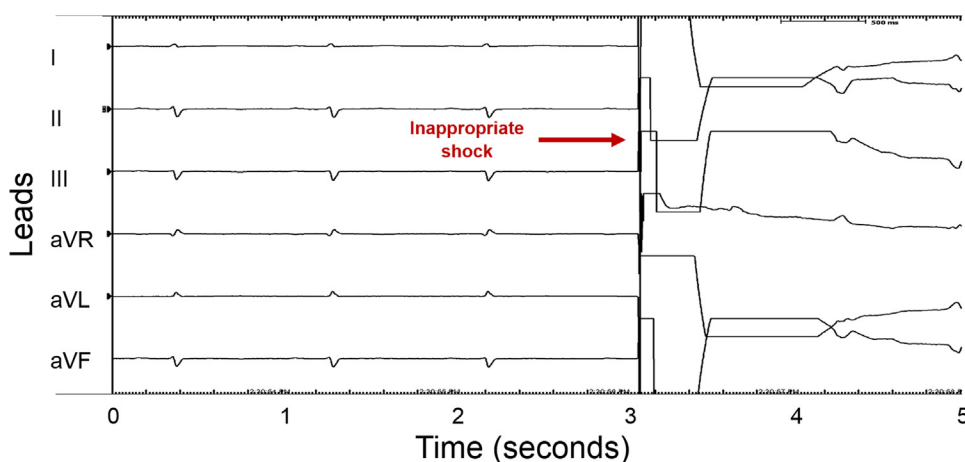
The patient was taken urgently to the electrophysiology (EP) lab for evaluation of lead integrity and emergent generator extraction and exchange. During the procedure, the patient continued to receive multiple shocks while in sinus rhythm (Figure 1). The lead, which was a Guidant Boston Scientific model number 0148 Endotak Reliance implanted in 2002, was examined under fluoroscopy (Figure 2, and video 1, available online), which showed normal position, and via pacing system analyzer, which showed normal impedance of 560 ohms, normal sensing of more than 12 mV, and normal threshold of 1.25 V at 0.5 milliseconds. A new generator was placed and connected to the chronic lead. Evaluation of the new generator showed normal function with cessation of inappropriate shocks. The patient recovered uneventfully and was discharged the next day.

In our particular case, there were no presenting arrhythmias, either ventricular or supraventricular (Figure 1); there were no separate pacing systems that could interact; and there was no electromagnetic interference, since the patient received shocks in 3 different places (device clinic, our observation unit, and EP lab). Lead failure due to fracture or insulation break is a far more common cause of inappropriate shocks than generator failure. The lead, however, was intact and its function was within normal limits when tested with the new generator. Magnet application should have inhibited any therapies in the case of a possible oversensing scenario. The company's report concluded that the source of the problem was the generator indeed, but the company was not able to determine the root cause of its malfunction. It also remains unclear if this was triggered by the process of wireless interrogation or if this was a pure coincidence. There are 2 previous cases reported in the literature about pulse generator failures. The first one was by Carpenter et al³ in 1998, in which they reported a generator that was constantly pacing despite the placement of a magnet and turning its functions off. The cause was later identified as an oscillator failure. The second case, by Zaim et al⁴ in 2002, was that of a generator that was delivering continuous ventricular pacing and for which treatment was also to change the generator. However, the circumstances of that case were unclear, as the patient presented to the emergency room with chest discomfort. He was also never shocked, and his device failed to deliver therapy in response to ventricular fibrillation induced by the device itself.

Figure 1 Inappropriate shock delivered in normal sinus rhythm.

The team exhausted all possible solutions before deciding to take the patient to the EP lab. In the case of our "runaway defibrillator," the only solution was to do an emergency intervention with generator replacement.

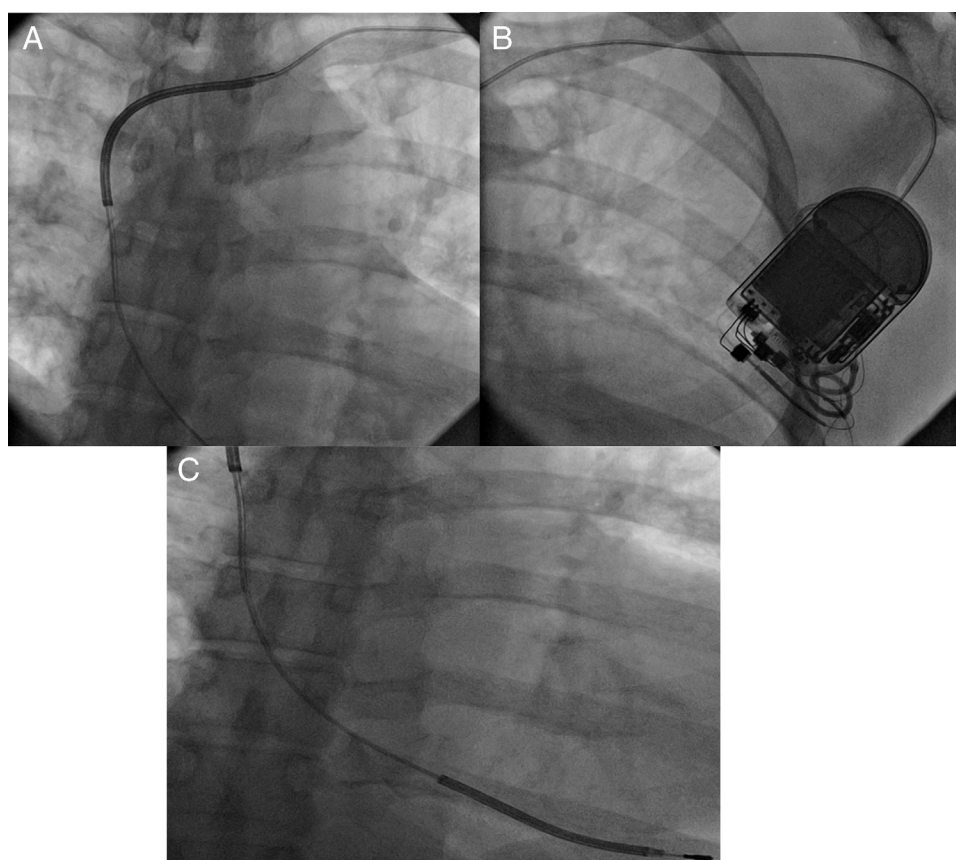
Figure 2 A, B, C: Still images of the cine loop taken for the lead to examine its integrity before changing the generator. The lead appears intact.
